**Township of Parsippany – Troy Hills
Evaluation of Water Service Failures in the
Glenmont Commons Development**

Final Report January, 2015

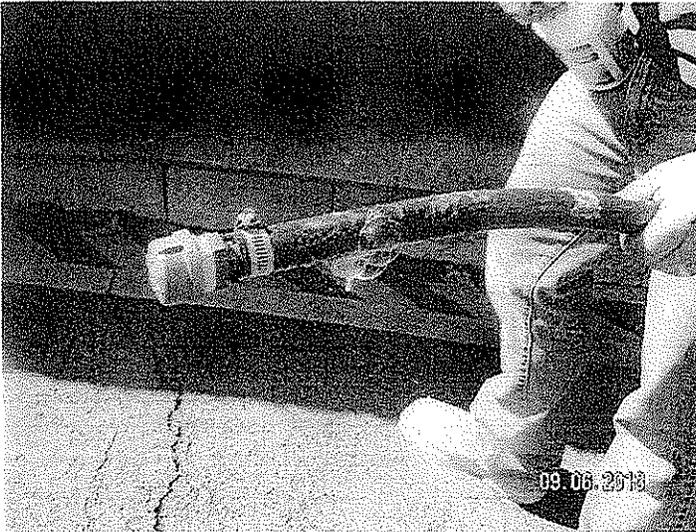
173 Springhill Drive: Small puncture in pipe determined when pipe was pressure tested.¹

During our observation it was noted that rocks of varying size where being removed from the excavation. These rocks were also present in the embedment zone of the pipe. The rocky fill was present throughout the excavation. We did not observe any select backfill on the private property. Just the mix of rocky fill that is native to the mountain.

The area of the leak was located 12 inches from the foundation. This area had significant settlement prior to the start of work. At no time did the leak make its way to the surface. It was noted that rocks where directly on top of the pipe at the point of failure. The pipe also was severely deflected either from settlement or from the backfill process at the point of failure. The failure was a small puncture created by the rock which was in contact with it. The Water Department has this section in their possession.

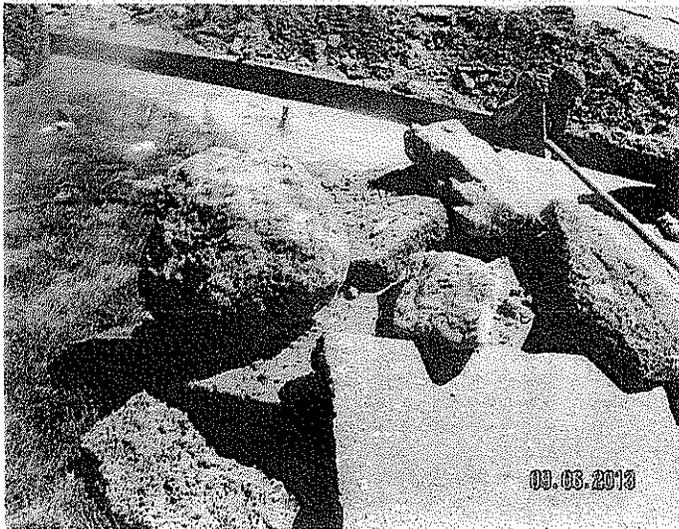
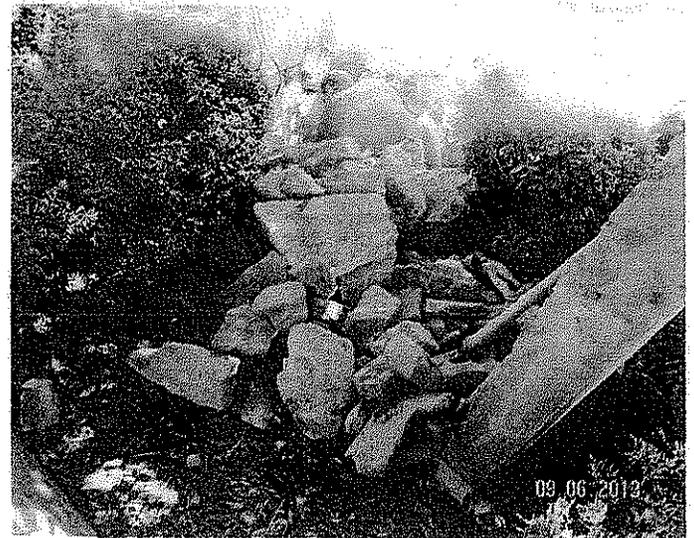
173 Springhill Drive: Pictures above show excavated material from line replacement.¹

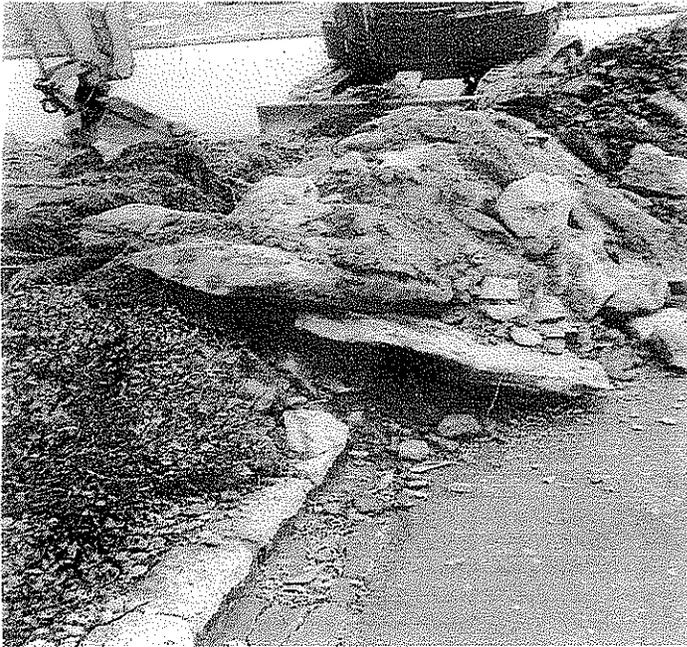
30 Seasons Glen: Existing service installation with no controlled back fill and large rocks against the service line.²

There is significant evidence of very poor installation procedures for the water service lines. The piping was not installed per the manufacturer's recommendations which call for the pipe to be installed in select backfill material (i.e., sand) that is free of debris and rocks. Appendix E: Plastics Pipe Institution, pages 27 – 34, outlines proper installation of PE water service lines. Additionally the 1996, 2000 and 2003 National Plumbing Code Illustrated also specifies proper installation procedures. There are many photographs and field observations of uncontrolled backfill material and rocks in direct contact with the pipe material.

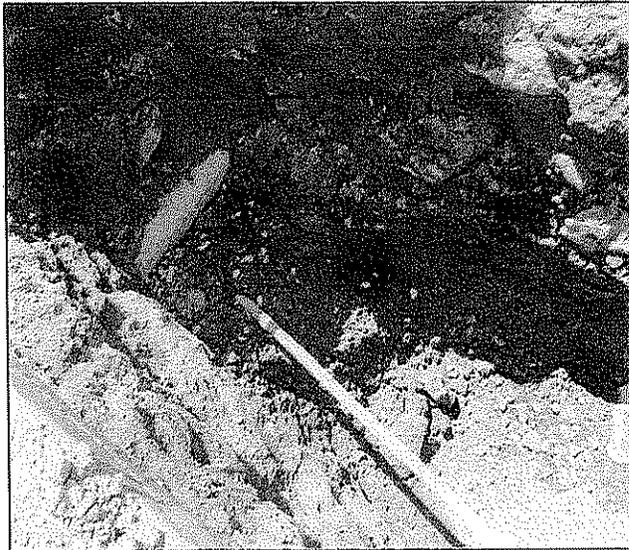
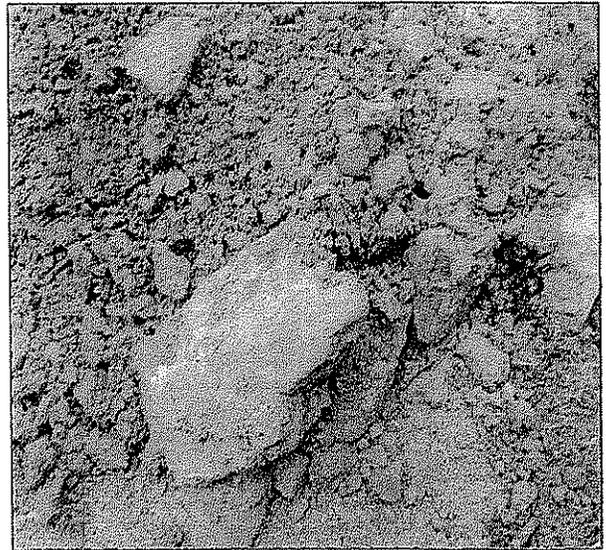
124 Springhill Road: Existing service installation with no controlled back fill and large rocks against the service line.³

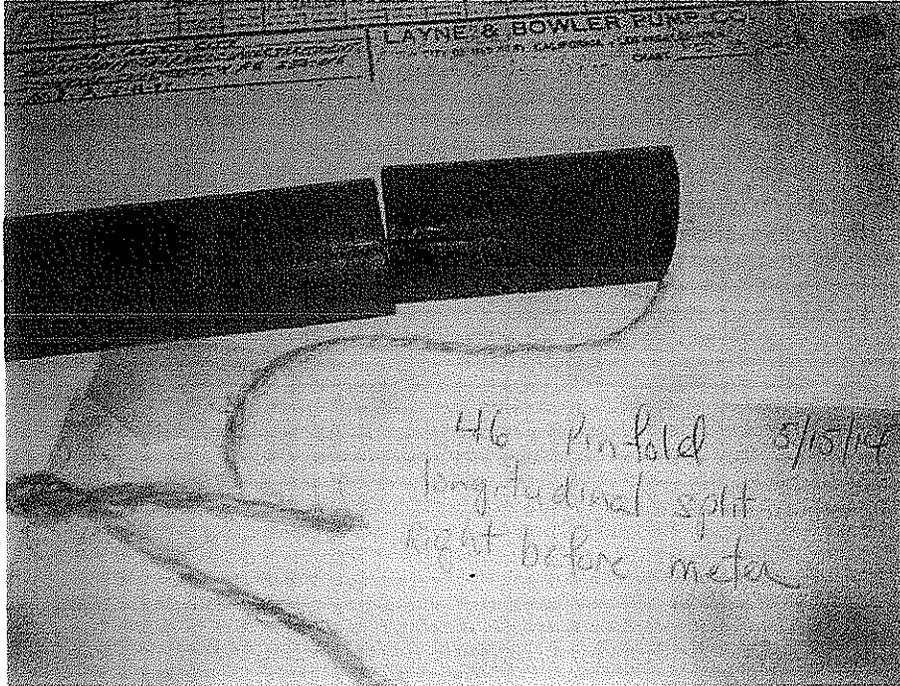
46 Pinfold Court: This pipe was cut in half after removal from inside wall of the residence. A longitudinal split can be seen on both sections of pipe. This sample was sent to Dr. Zhou, DOW Chemical for testing on July 22, 2014.⁴

On May 15, 2014, the Township obtained another sample pipe from the residence at 46 Pinfold Court. This pipe shows a longitudinal split as well as the pipe sample obtained from 11 Summer Hill Road obtained on September 19, 2014. The location of the failure was inside the residence at 46 Pinfold Court and therefore, not associated

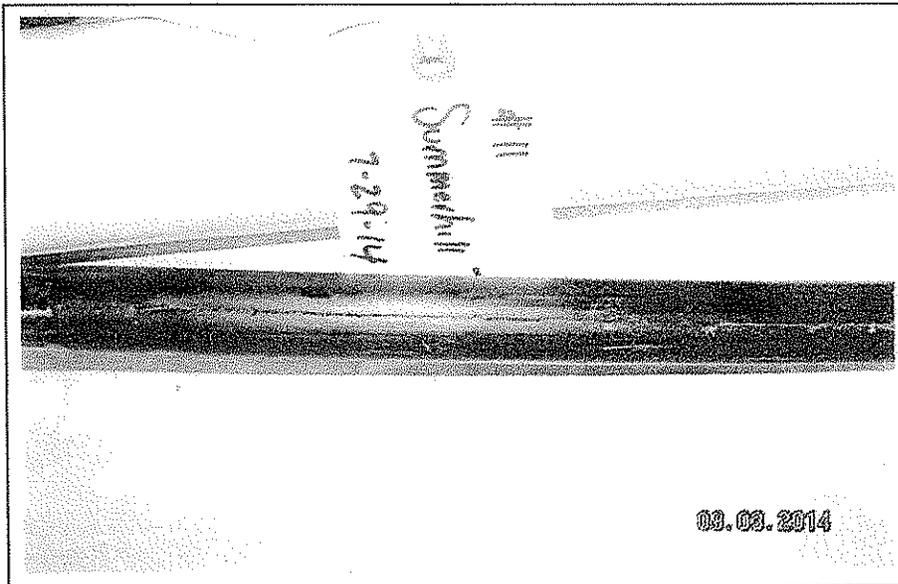
11 Summerhill Drive.: A longitudinal split can be seen. Received on 7/29/14. Sent to Dr. Zhou, DOW Chemical for testing on September 19, 2014.⁵

with any poor bedding installation outside and location of the failed pipe at 11 Spring Hill Drive was the underground service on the home owner's property leading to and underneath the porch.

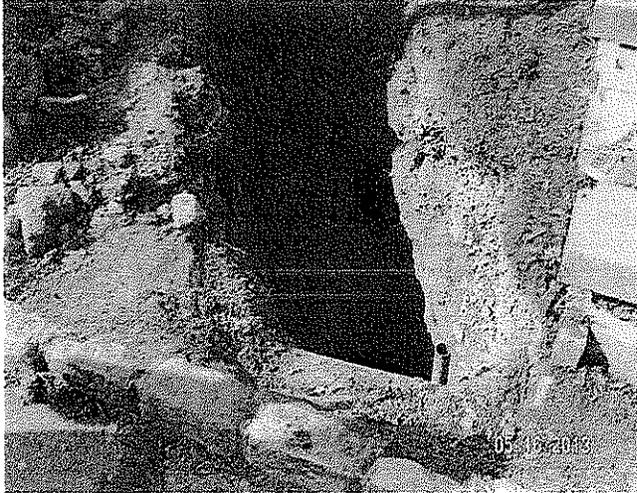
The Township also collected a sample of pipe from 17 Summerhill Dr. with a longitudinal split identified by Township personnel (no picture available of failed pipe; however, below are pictures of the trench that once housed it along with extracted backfill).⁶

- One sample of pipe (173 Springhill Drive) had a “ductile” failure when pressure tested to 850 psi and 900 psi. This is the normal anticipated failure mode for the pipe;
- One sample of pipe (17 Summerhill Drive) has a “non-ductile” failure when pressure tested to 550 psi and 600 psi. This failure is classified as “brittle” and is not the normal failure mode;
- Endot indicated that a test performed for depletion of anti-oxidant in the pipe, noted that the anti-oxidant package was somewhat depleted, but not enough to explain the brittle failure of the one piece of pipe;
- Endot requested additional information for the environmental factors associated with the pipe (i.e., water temperature, chlorine residual, internal pressure of the pipeline, pH of water)
- Endot indicated that additional testing will be performed by Dow on the pipe samples
