**Township of Parsippany – Troy Hills
Evaluation of Water Service Failures in the
Glenmont Commons Development**

Final Report January, 2015

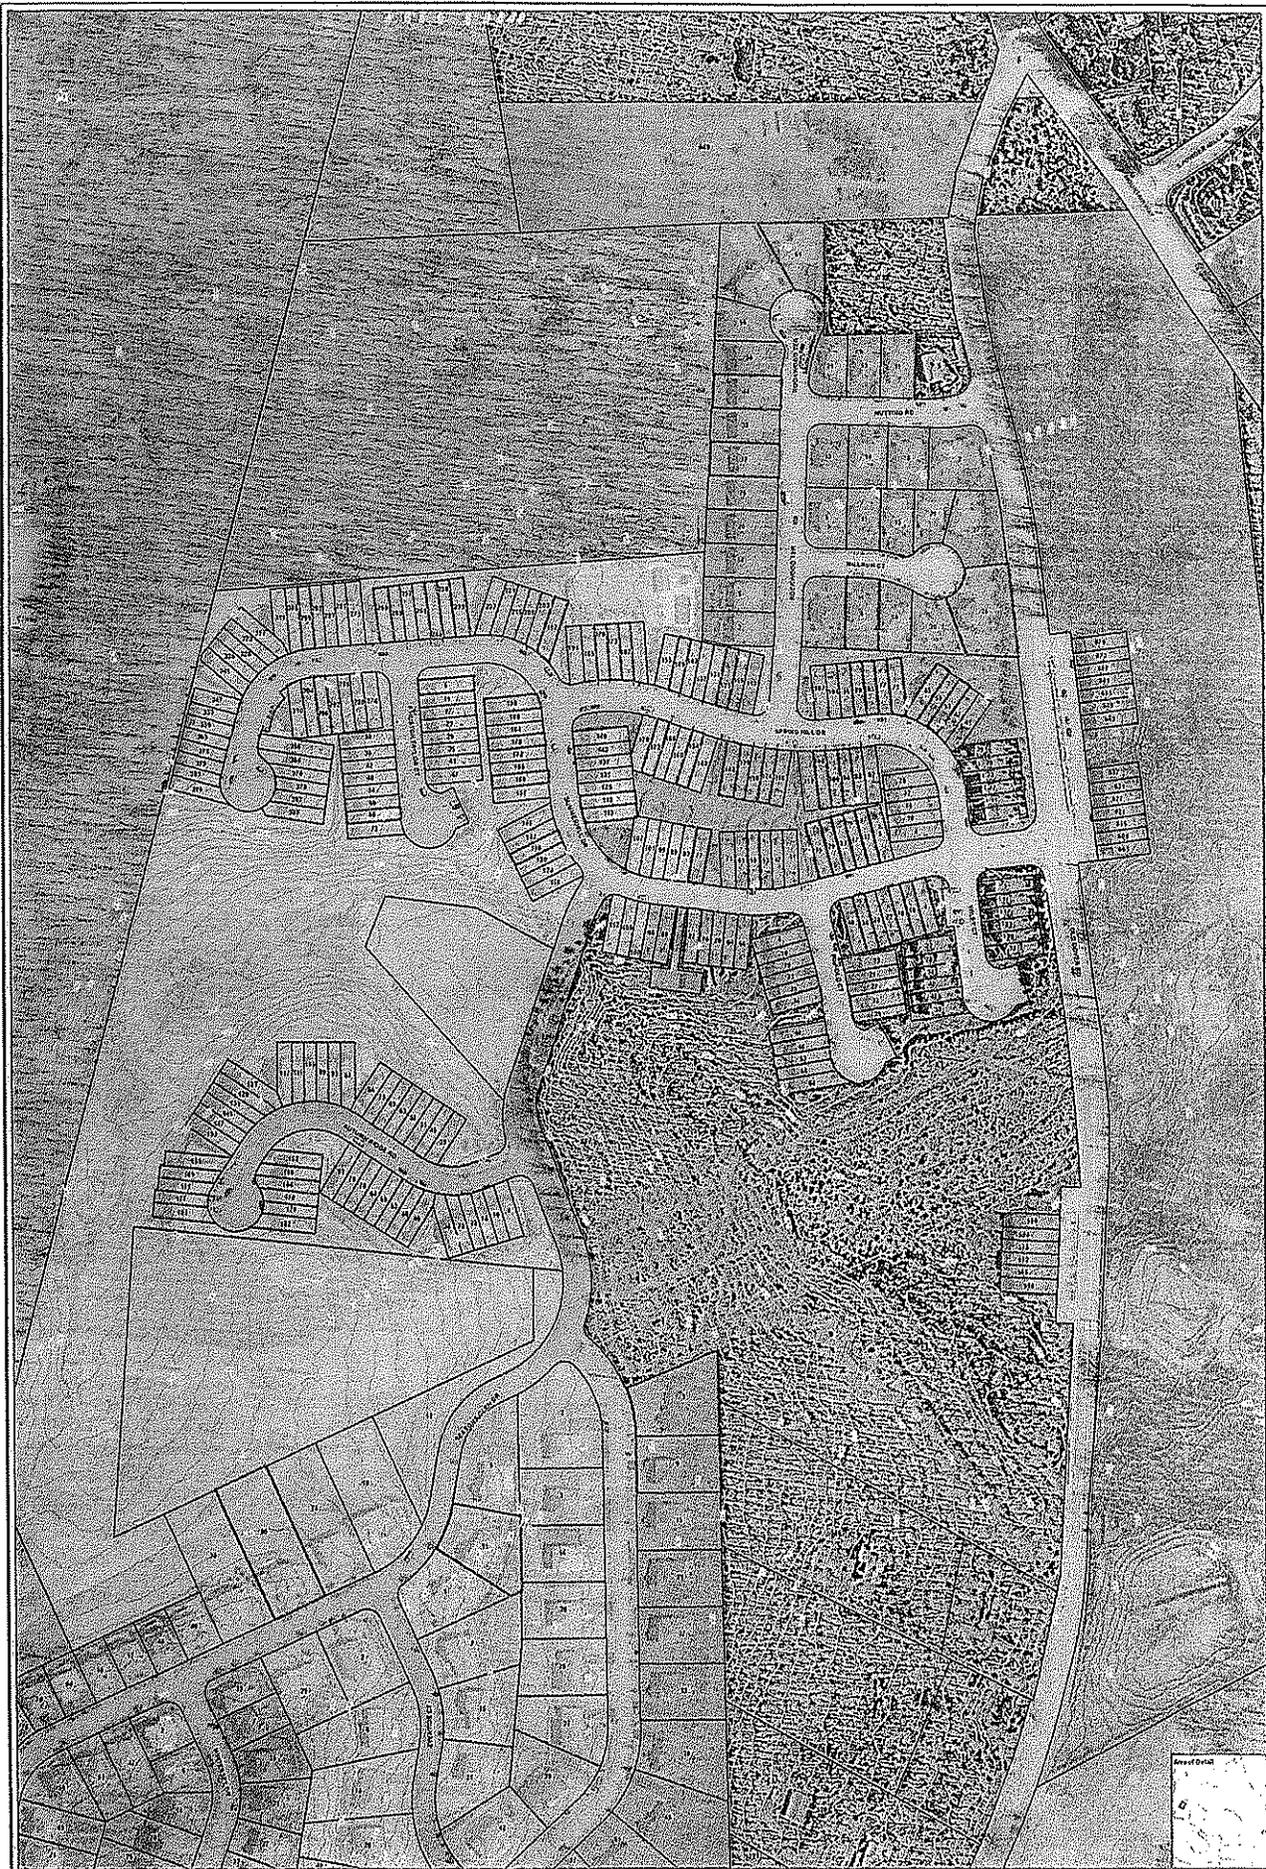
FAILURE LOCATIONS AND WATER SERVICE PRESSURES

TOWNSHIP OF PARSIPPANY-TROY HILLS
 MORRIS COUNTY, NEW JERSEY
 GLENMONT COMMONS STATIC PRESSURES

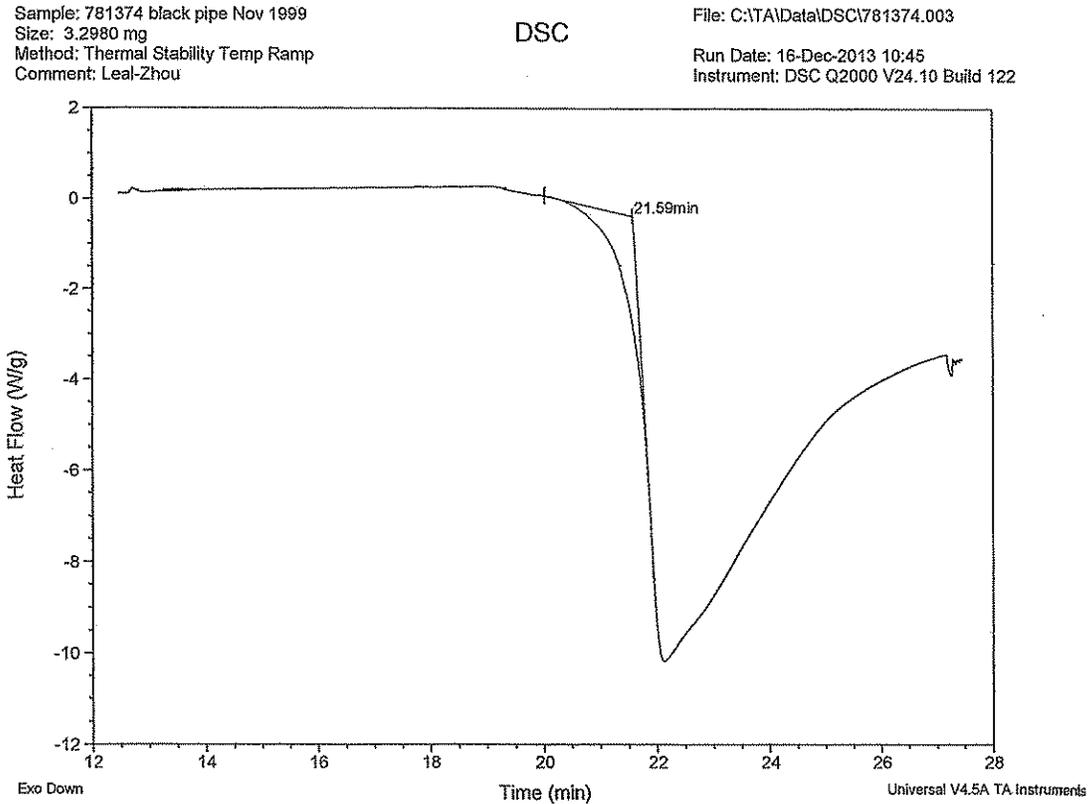
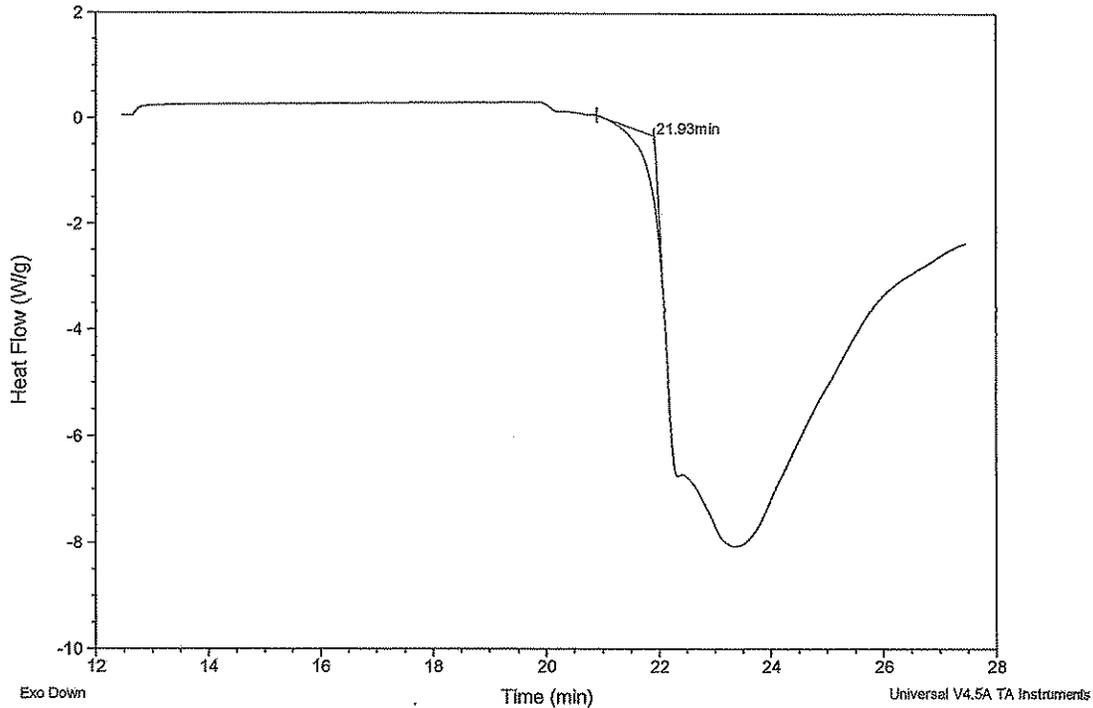
The following DSC charts measured the thermal stability in OIT (Oxidation Induction Time). They are in the low end of the specification but still meet the product and standard requirement. The two samples essentially had the same level of AO package.

It is common to have relative low AO concentration in service pipe due to the slow leaching out of AO additives by water transportation. Pipe extrusion might decrease the AO concentration but it would take 7 to 8 extrusion cycles to see a significant decrease.

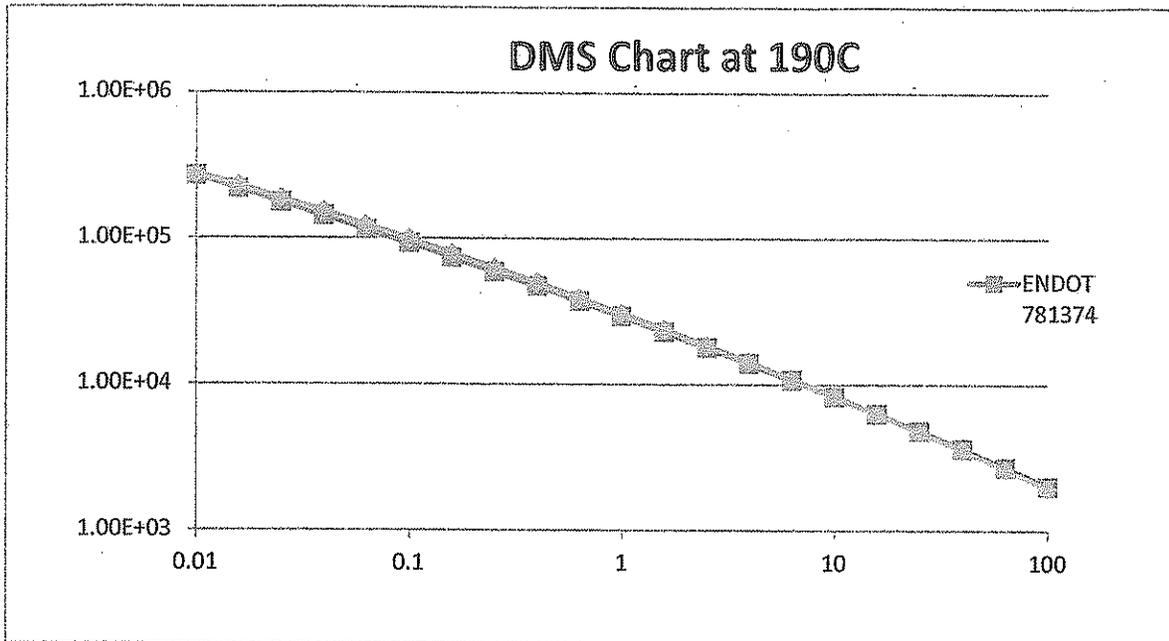
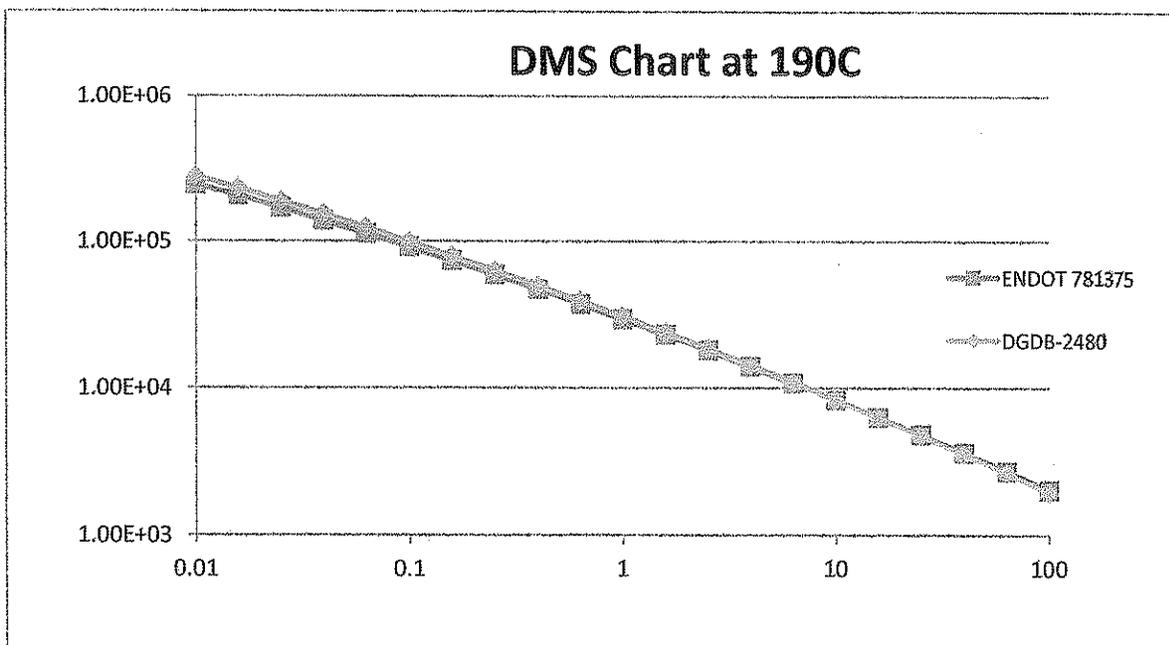
3. DMS data

The following charts are the viscosity versus shear rates of the two samples at 190C. Since most likely DGDB-2480 resin was used to make the pipe samples, DMS chart measured from virgin DGDB-2480 resin was taken as a reference to compare with that measured on the two field pipe samples. 781374, the 1" black pipe with printline of November 1999 is identical to that of the virgin DGDB-2480. 781375, the 1" black pipe with red tape is almost completely overlapped with the exception of the lower viscosity curve at the low shear rates.

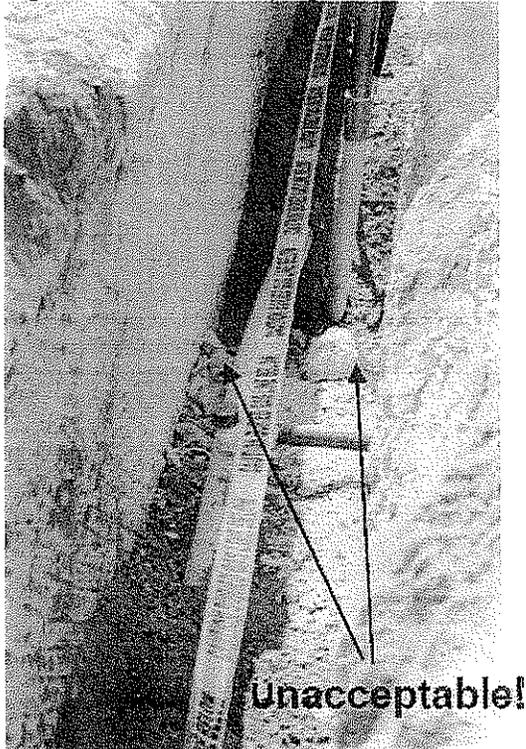
Fig. 25: Avoid Rock Impingement when Placing Embedment

Backfill under the pipe haunches to at least 6 inches above the pipe with the select embedment soil. Shovel slice or compact in lifts not exceeding 8" as required. Place lifts evenly on both sides of the pipe. Rock impingement may cause high contact stresses and stress raisers in pipe wall. Keep large hard objects away from the pipe. See Figure 25.
